Sewer lining works recommenced this week following Mental Health Awareness events the previous resulting in a further 180m of public and private sewer lined.

Progress Update:

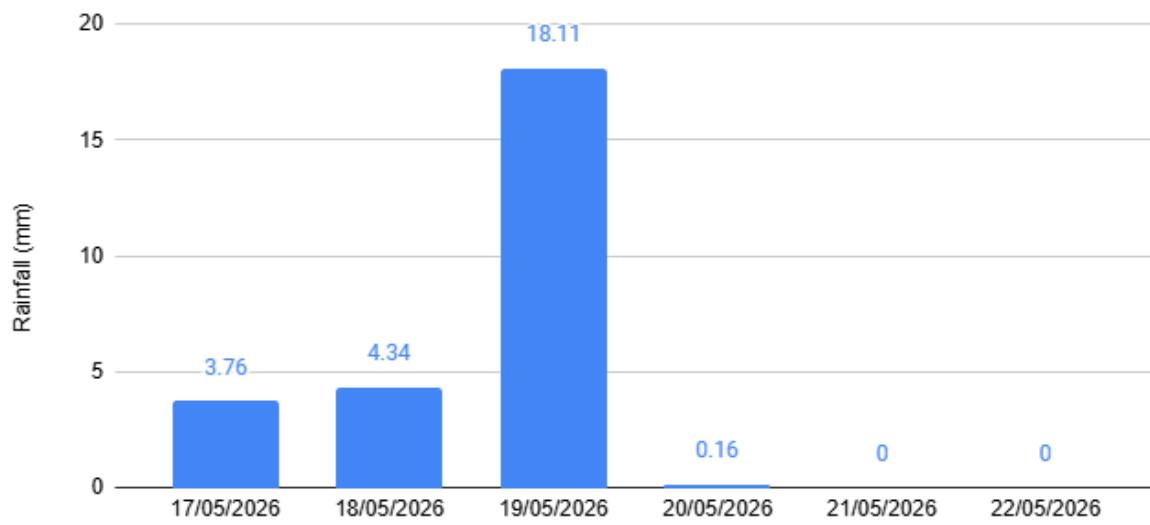
Chilgrove Rainfall

The ground water continues to fall and we will monitor this to find more localised issues created by this years ground water season.
